Sonia Cedrés de Bello – Architect

# Remodelling healthcare facilities with limitations

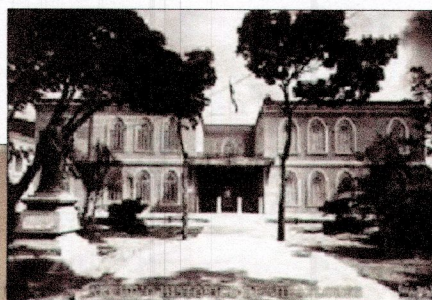
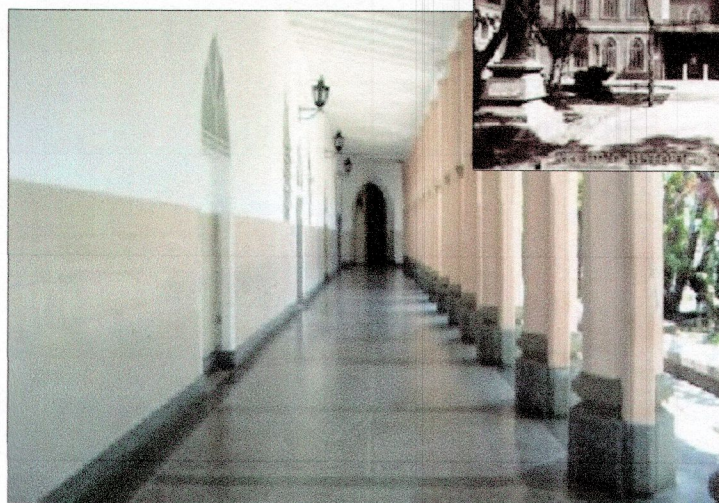
The Hospital Vargas is the oldest hospital of the city of Caracas.

The building is located in front of a street with a depth inclination that make it possible to have direct entrances to two floors, allowing for the separation of the pediatric and adult emergency departments, as required by the national norms and regulations of Venezuela.<sup>3</sup> The main entrance and façade of the hospital is over the same street.

At the south border is a contemporary tall building which holds imaging and lab services, and on the east side is the internal access to the hospital through a corridor

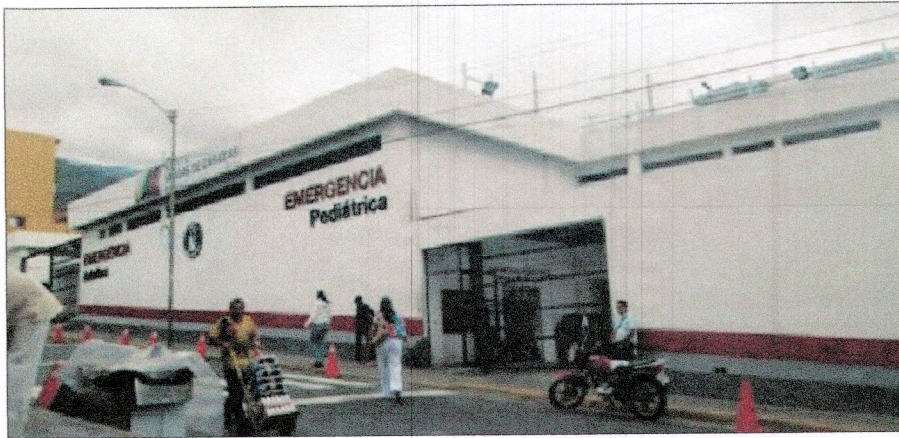
The paediatric emergency entrance.

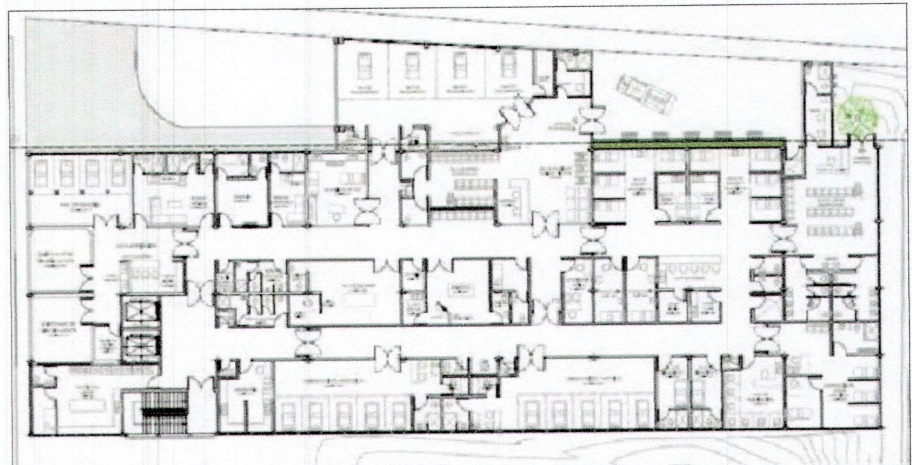
The adult emergency area occupies the third-floor, with direct access from the upper side of the street. There are two entrances, one for ambulances and other for walking patients.

**Adult Emergency:** Occupies the third floor, and has direct access from the upper side of the street. There are two entrances – one for ambulances and the other for walking patients. The trauma room has capacity for four beds and has a separate waiting area.

The treatment area has eight separate cubicles for general use and two cubicles for special treatment. Another area, for special victims, includes three beds, a consultation room and bath, and two individual isolated rooms with private bath.

A respiratory therapy room has capacity for seven reclining chairs, and an observation unit with two large rooms separated by sex, each having space for five beds. An area for traumatology includes cast room, X-ray and tomography. Each of these areas has a decentralised nurse station. There are two consultation rooms, an office for the director,

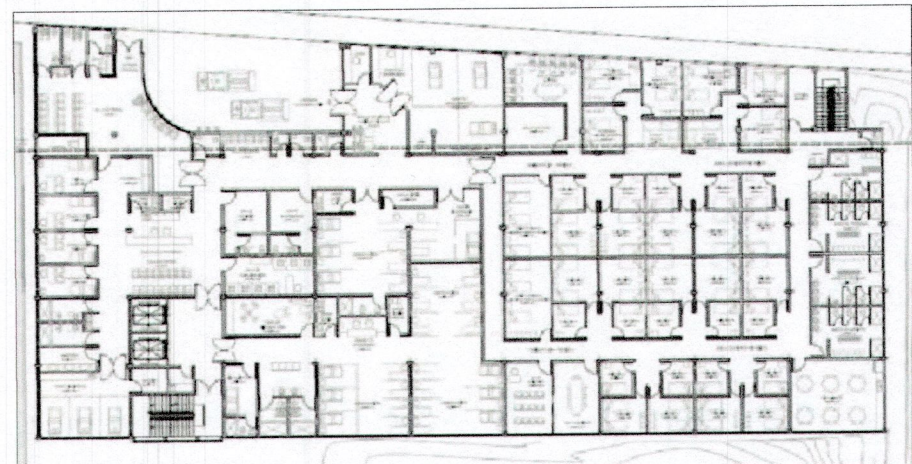
Paediatric emergency and doctors residences.

**Children emergency:** This area is located in the second floor. Regulations require separate emergency areas for children and adults, but they do share the use of imaging equipment. This department also has two different access points – one for ambulances with direct access to the trauma room which has a capacity for three beds and another for walking patients.

The trauma area is internally close with two rooms for intermediary care – one with two beds for critical patients and other with six beds, with a nurse station integrated. The walk-in entrance has a waiting area and a treatment unit. This treatment unit has a central nurse station and a sub-waiting space. Around this area, there is a station for weight and size, four consultation rooms, and a bath for babies, a procedures room with three beds, a respiratory therapy room with seven recliner chairs, and an isolation room. Further, in a separate area with natural light, there is an observation unit with capacity for 20 beds and cribs with a psychomotor room, baths and nurse station. In all these areas, parents are allowed, and indeed encouraged, to be with their children.

**Doctors residencies and staff rooms:** On this floor there is also an area designated for staff and residents. This has 12 beds for staff and 48 beds for residents that overnight in

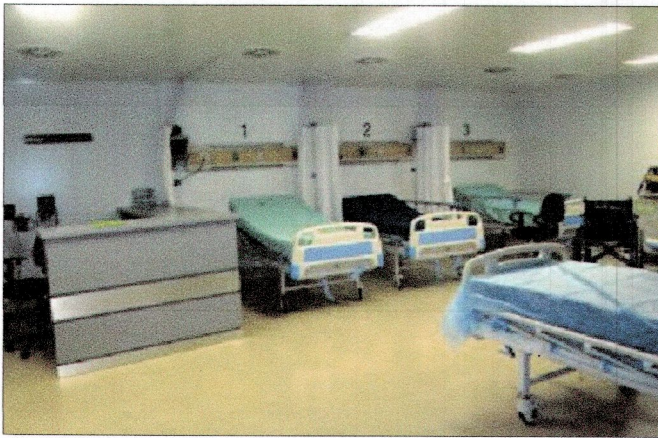
The newly remodeled preparation room in the surgery suite.

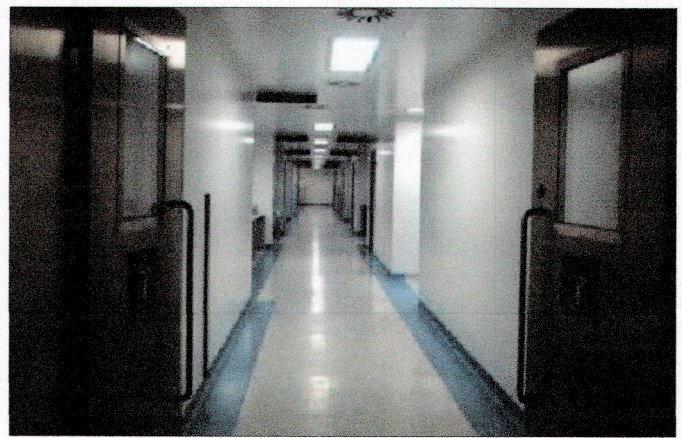
The new surgical suite.

**Surgical suite:** The first floor of the building holds the surgical suite, which connects directly with the ICU and inpatient rooms located in the old building through a corridor. There are eight operating rooms (OR) with a central corridor and a peripheral one to circulate the soil material that connects directly with the central sterile supply. At the suite entrance patients are transferred, from exterior to interior strollers, into the preparation room with nine beds. There is a recovery room with 16 beds. Ancillary spaces – a kitchenette, rooms for on call doctors, sanitary areas, meeting rooms, offices, and consultation area – are located outside of the restricted area close to the floor access.
